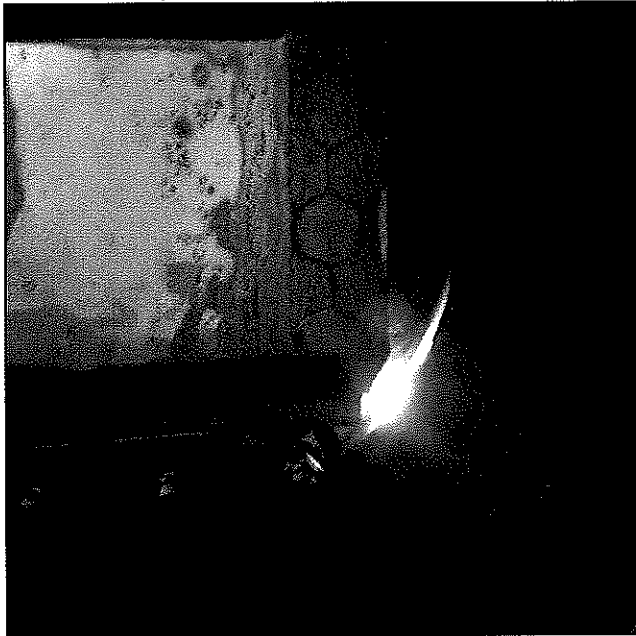
- Positive material identification (PMI) indicated that weld repairs performed in 2013 were performed with materials specified for the spent slide valve.¹⁷
- Clearances measured with a feeler gauge indicated that the leading edges of the valve gate (referred to in the Z&J report as the “disc”) were washed out and that the gap was too large to measure with the feeler gauge.¹⁸
- Photos of the cleaned spent slide valve gate and seat ring (Figures 23 and 24) confirmed what was seen at the site. Damage was significant to both the gate and seat ring, easily allowing catalyst to seep through the gaps from the reactor into the regenerator. Also easily allowing air to flow from the regenerator into the reactor once the catalyst above the spent slide valve was gone.

Figure 23: Light shining through the gap between the spent slide valve gate and seat ring.

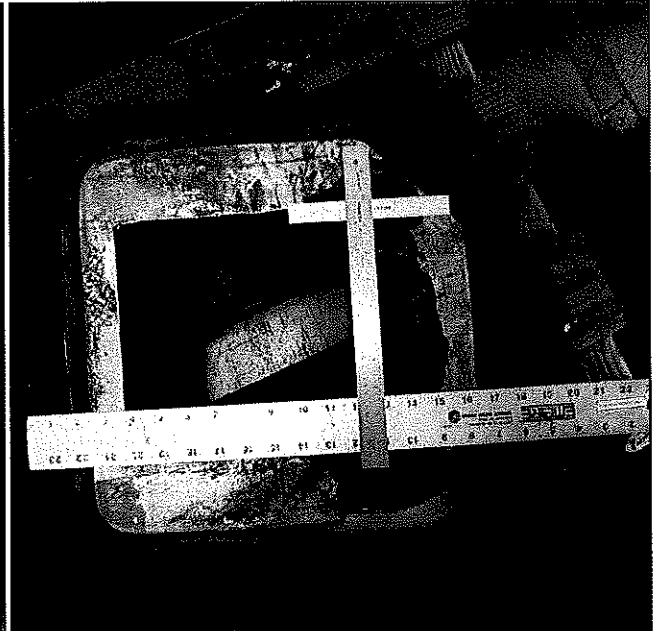
Figure 24: Damage to the spent slide valve seat ring once disassembled.

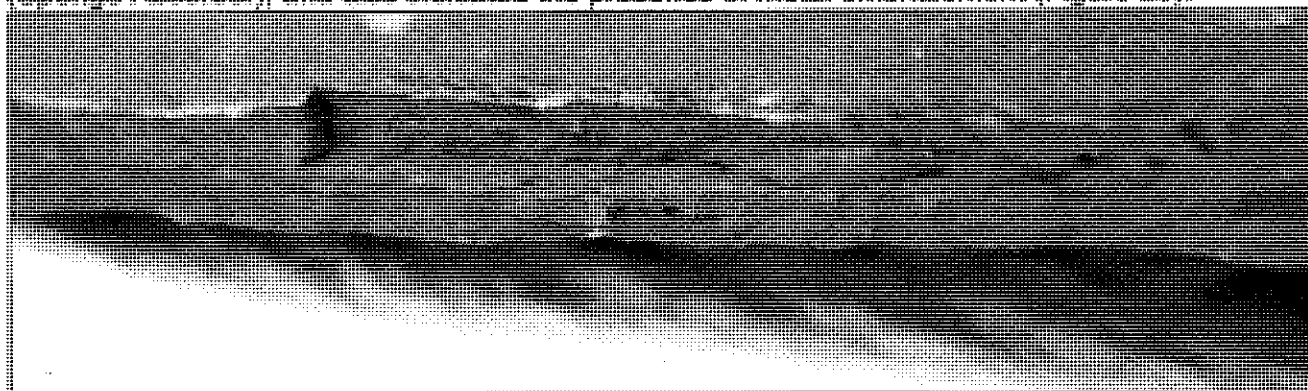
Metallurgical testing of pieces of the failed absorbers, performed by the OSHA Material Failure Team in October, 2018, positively identified them as A-212 (Primary Absorber) and A-201 (Sponge Absorber), and also indicated the presence of metal embrittlement (Figure 25).

Figure 25: Metal fatigue cracking evident on the metal shell.
